Line Item Price Form

Fairway 2 Sorted by ID#

FAIRWAY TWO - MAINTENANCE INSPECTION REPORT

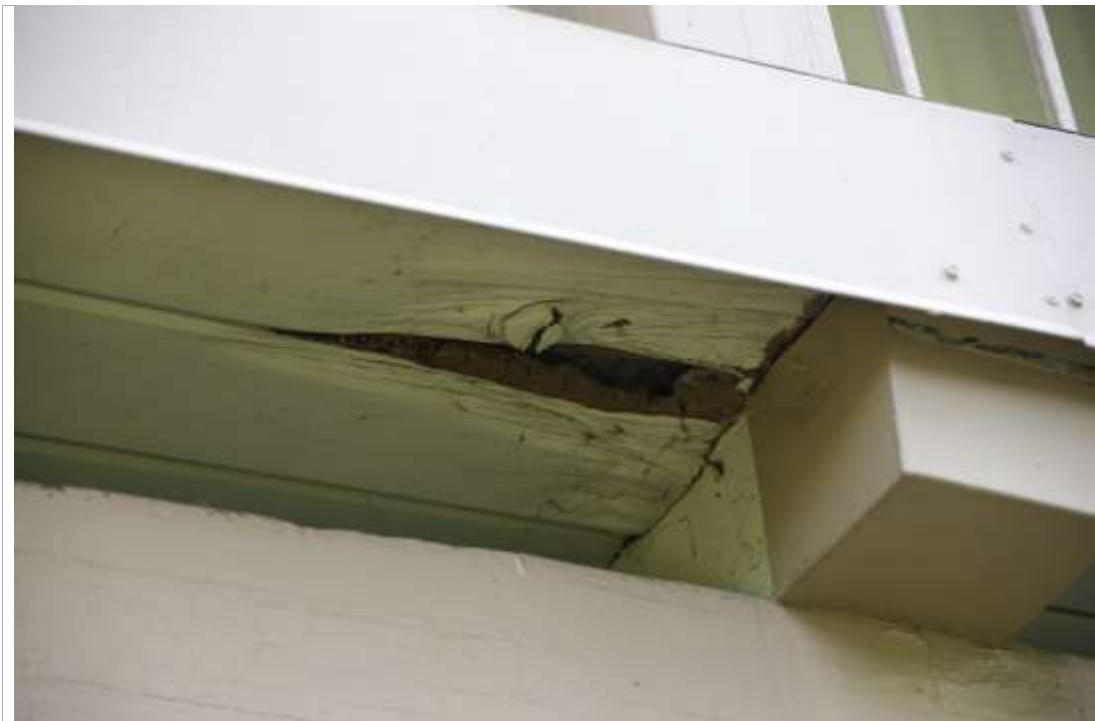
ID #	1	Photo Reference Number	3352
Category	Dry Rot	Location	Unit 1
Severity	2 - Important, Repair Soon

Landing above Unit 1 has dry rot on 6ea 1x6x12' T&G decking.

Pull 6ea 1x6x12' T&G decking and replace with new 1x6x12' T&G

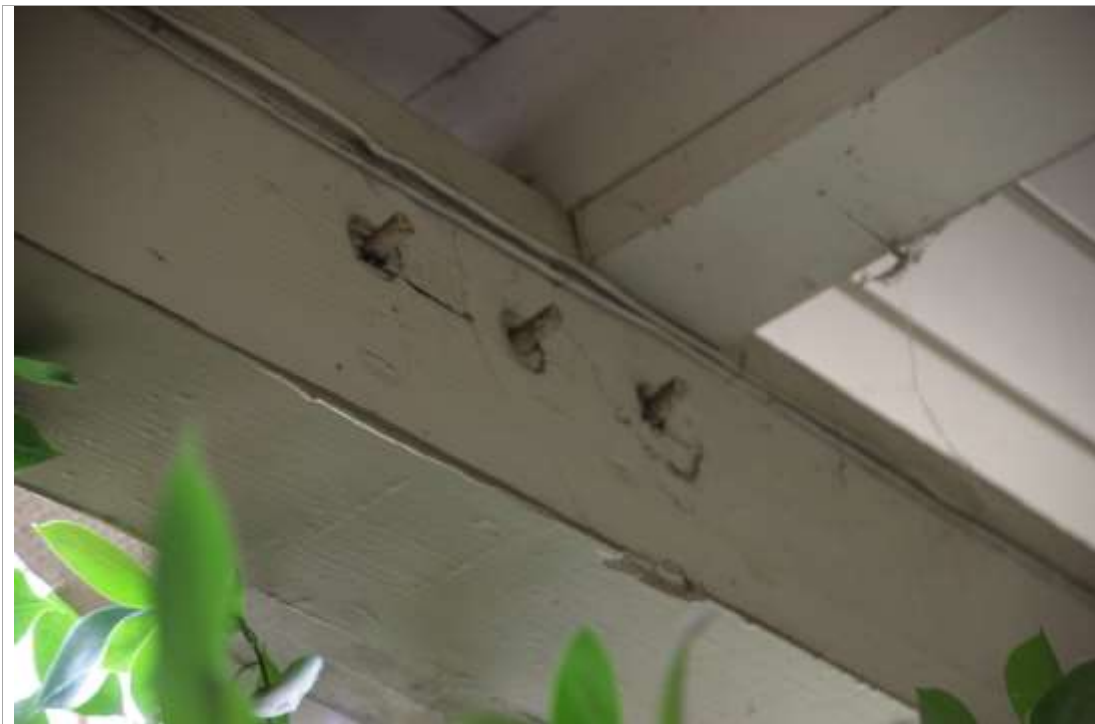
ID #	3	Photo Reference Number	3561
Category	Structural	Location	Stairwell Between Unit 1 & 2
Severity	2 - Important, Repair Soon

Inner stair roof beam that ties to deck beam is missing structural nuts. The bolts are stripped, between unit 1 & 2.

Pull old bolts as the threads are stripped and put new bolts in, then install new nuts to tie deck beam to inner stair roof beam.

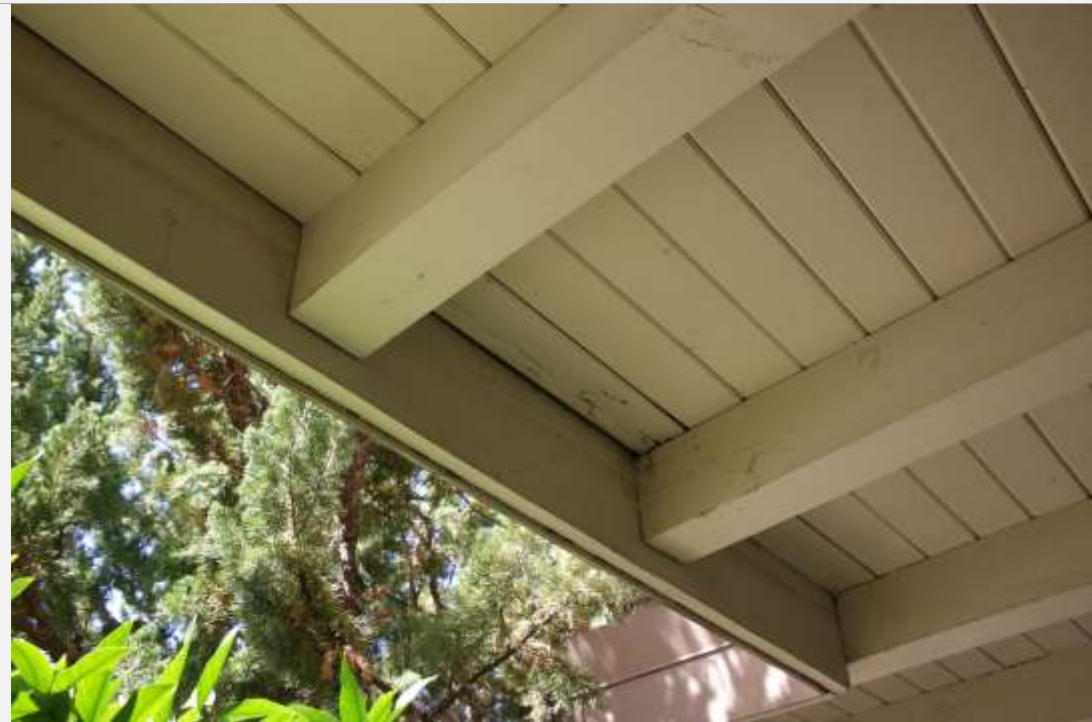
ID #	4	Photo Reference Number	3569
Category	Dry Rot	Location	Between Unit 2 & 2
Severity	2 - Important, Repair Soon

Stairwell roof beam right of unit 2 at metal posts: Dry rot at supporting 2x4, (between beam and two metal posts) and 1x4 outer fascia (about 2').

Remove supporting 2x4, (two posts) and 1x4 outer fascia (about 2') and replace with new 2x4 at metal posts, and 1x4 fascia.

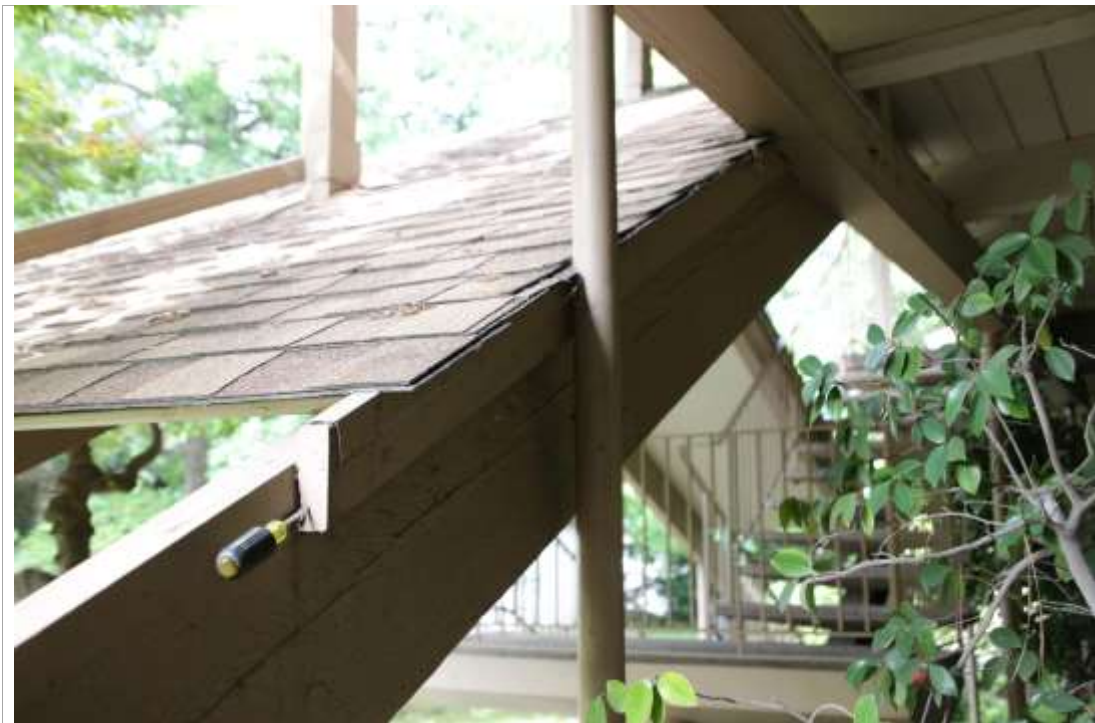
At the inner roof stair beam right of unit 2, a 5' section of 2x4 fascia needs replacement due to dry rot.

Pull and replace 5' section of 2x4 fascia

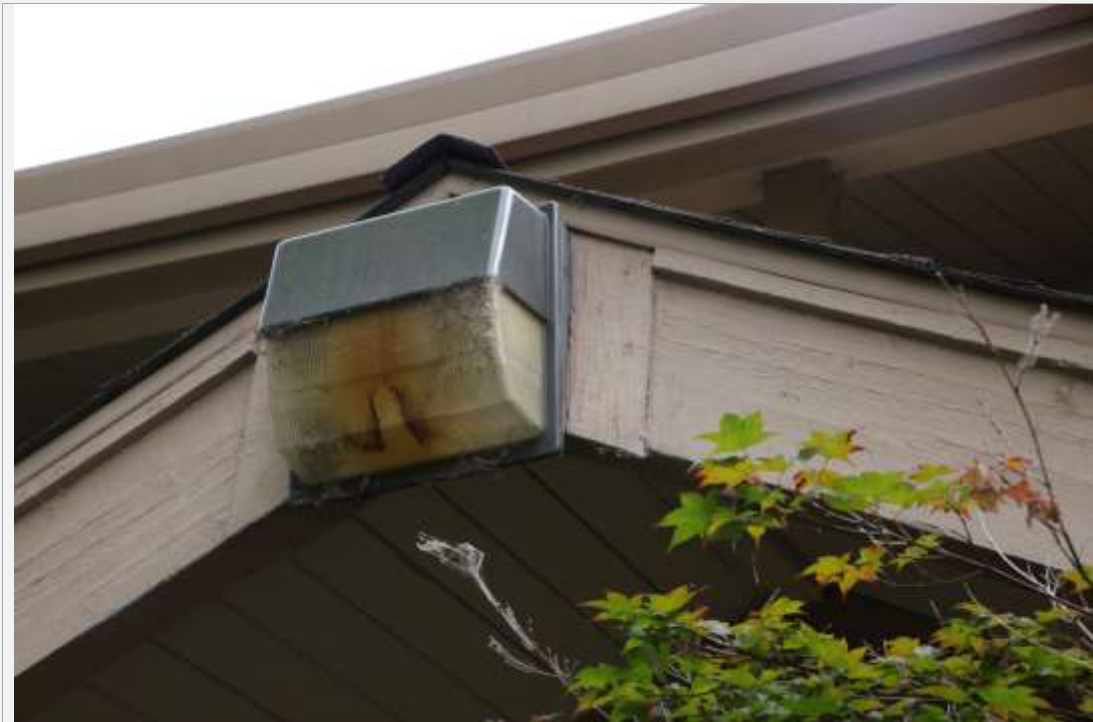
ID #	6	Photo Reference Number	3586
Category	Dry Rot	Location	Unit 2
Severity	2 - Important, Repair Soon

Near unit 2, the stair roof, at ridge, a plywood gusset needs replacig due to dry rot.

Pull light fixture back, replace rotten plywood gusset with new plywood gusset, and reattach light fixture.
