Line Item Price Form

Fairway 2 Sorted by ID#

FAIRWAY TWO - MAINTENANCE INSPECTION REPORT

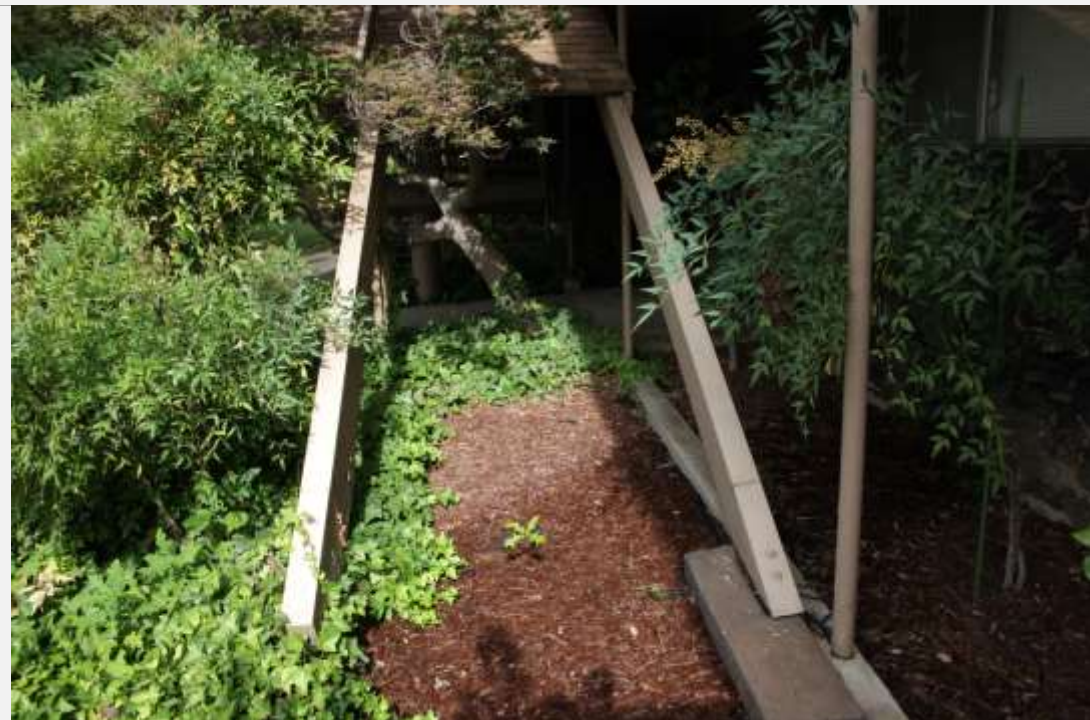
ID #	8	Photo Reference Number	3601
Category	Dry Rot	Location	Unit 2 Stairwell
Severity	2 - Important, Repair Soon

On the two 4x12x12' roof beams closest to the building on the east side of the unit 2 stairwell, there is dry rot up about 6 feet. It has not yet rotted clear through, and is still a solid member at this point.

Marry/lag a 4x12x12' beam to each of the two existing beams, shoot a treated 2x8 footing into the existing concrete footing,

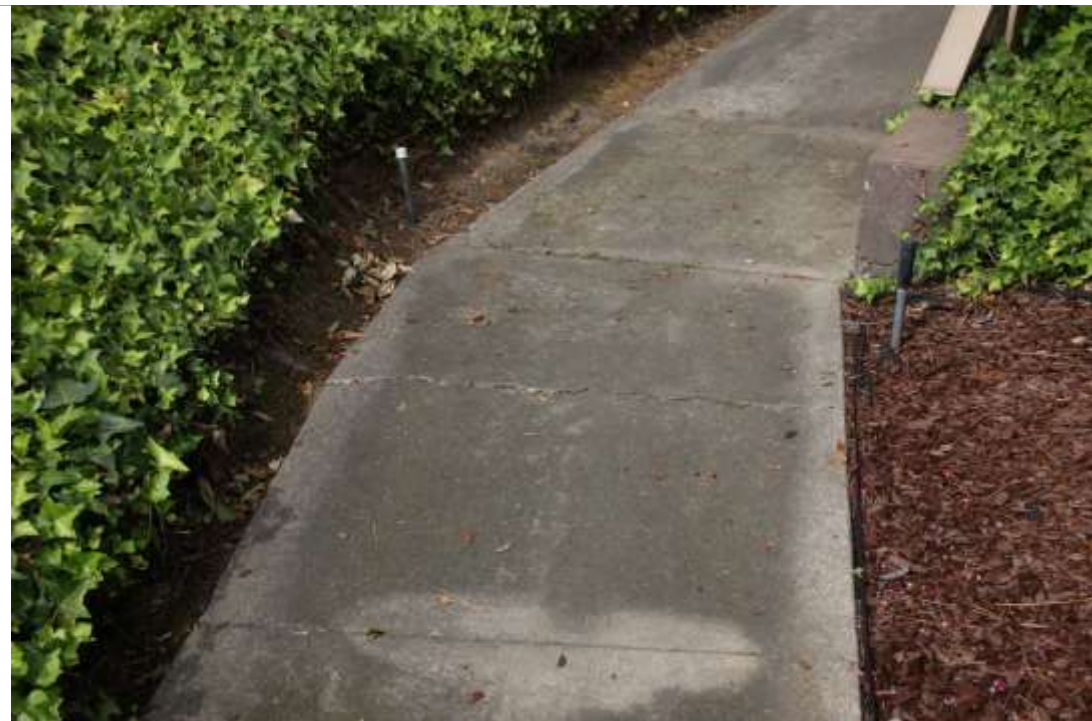
ID #	13	Photo Reference Number	3623
Category	Concrete	Location	Unit 2 Walkway
Severity	2 - Important, Repair Soon

There is a trip hazard on the concrete walkway between units 2 and 3 that appears to be caused by nearby tree roots.

Remove section and repour new section of walkway.
